**CALIFORNIA REGIONAL WATER QUALITY CONTROL BOARD - SAN DIEGO REGION
WATERSHED MANAGEMENT PROGRAM**

FACILITY INSPECTION REPORT

INSPECTION DATE: **01/12/2005**

Morro Hills Villages and Golf Course

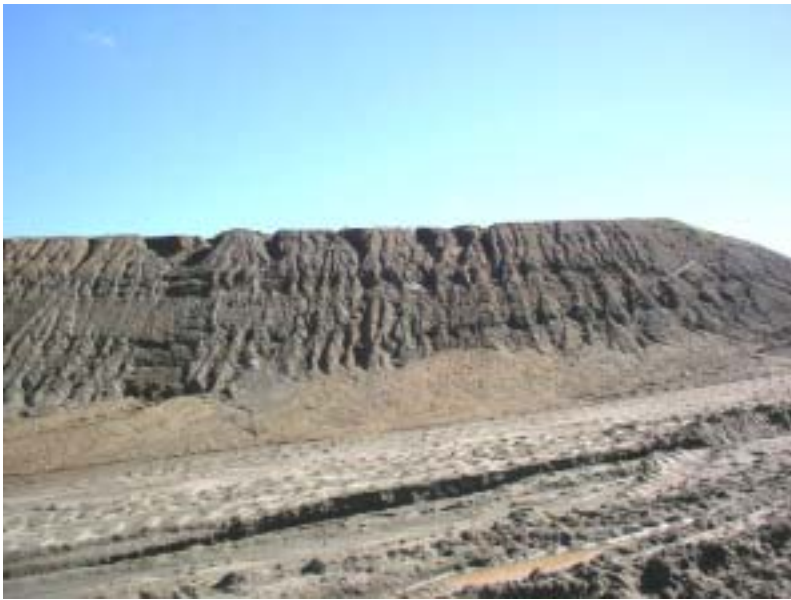
- Erosion control of any kind lacking on slopes throughout the areas undergoing construction under Florida Southchase's control, with the exception of the Golf course (which is for the most part complete), and Village K where barley is still being used as vegetated erosion control on large flat areas.

- Sprayed erosion control had allegedly been in place on slopes prior to the large October Storms, but failed, and nothing was done to fix them after those rains, which has lead to the poor condition of the site today.

Finished slopes throughout Villages under construction are lacking any kind of erosion control BMPs. These slopes gully and rill erosion are typical of a majority of slopes on site.

- Erosion & sediment control BMPs need to be implemented immediately to control capture and treat pollutants generated from site.
- Florida Southchase should share responsibility with Fieldstone for any discharges occurring from site.
- If sediment control BMPs are unable to contain sediment laden water onsite and Developers find themselves in need of pumping out again they need to ensure the effluent is filtered to the BAT standard. I discussed the use of Chitosan-enhanced sand filtration as a viable option. Due to the size of the project and the large amount runoff captured filter bags would not be a viable alternative.
- A follow-up inspection should be initiated prior to the City of Oceanside lifting the Stop Work Notice.
- Forward case to the RB enforcement unit for further action.

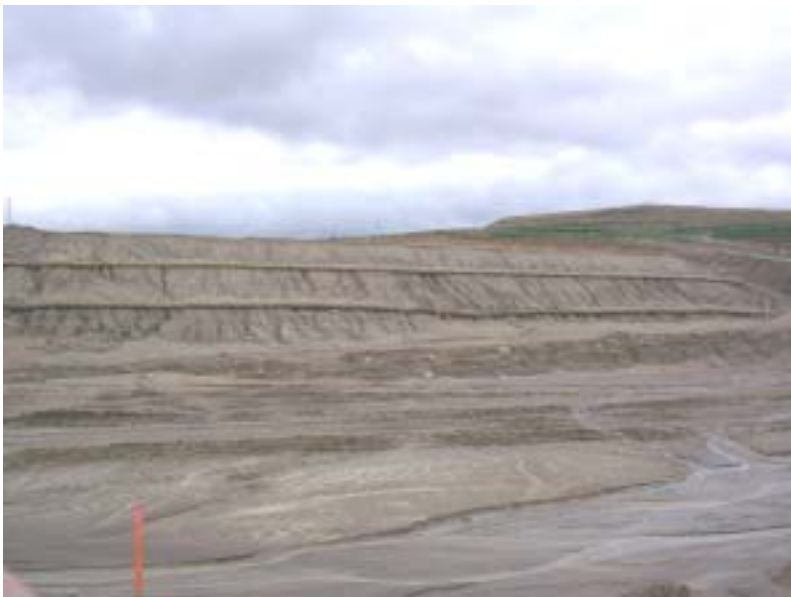
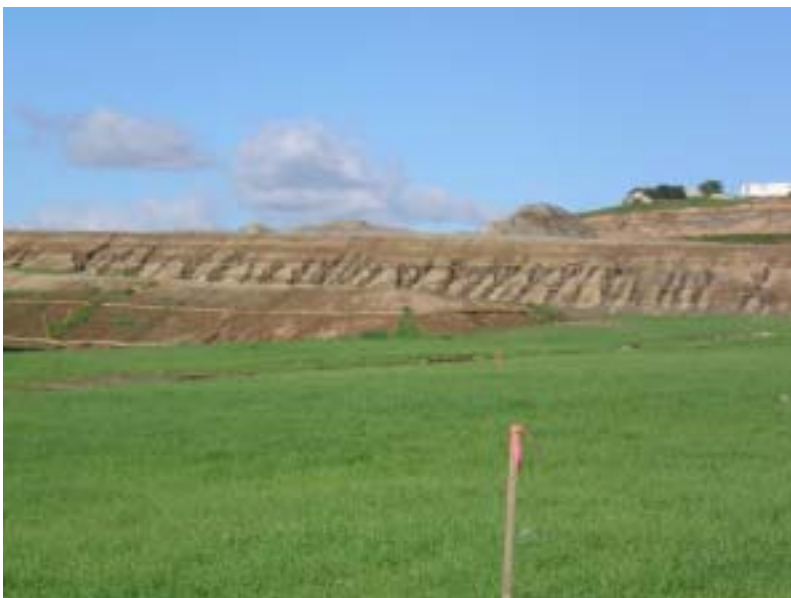
Village K utilized Barley on flat graded areas as effective erosion control, slopes however were suffering extensive gully and rill erosion.

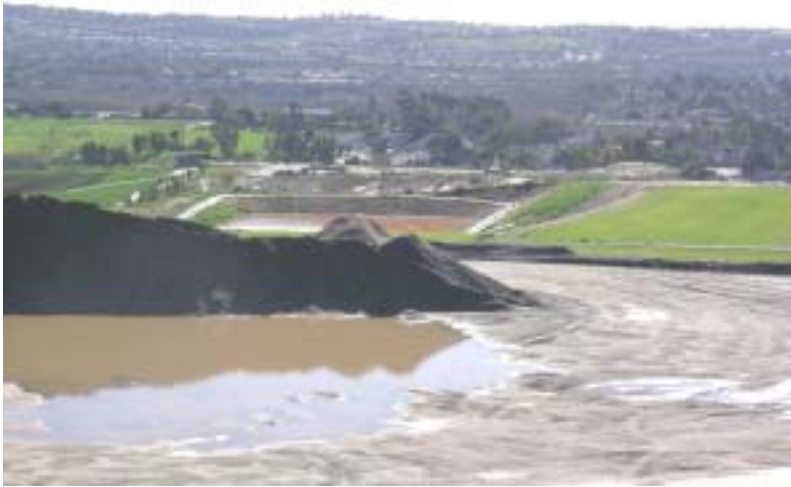
- The only apparent properly designed sedimentation basin is located in Village K, it was the only BMP (along with the barle that seemed to be functioning as designed on a site wide basis.

Village K also contained the only properly designed and functioning sedimentation basin observed by the Regional Board.

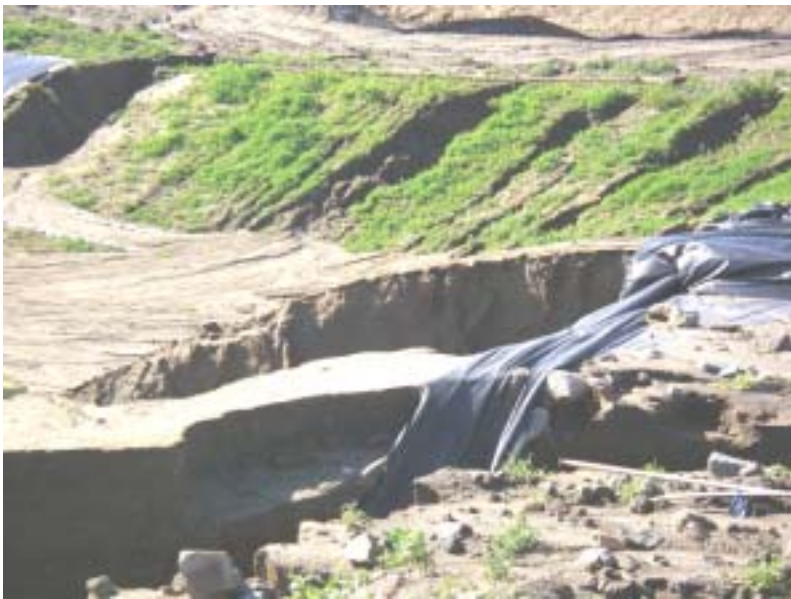
Previous rain events had caused sediment basin slope failure, and will need to be repaired.

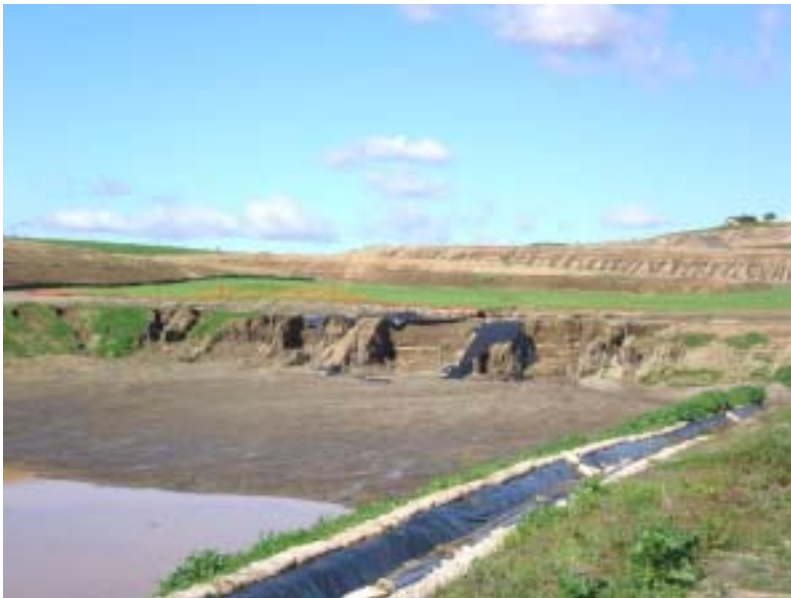
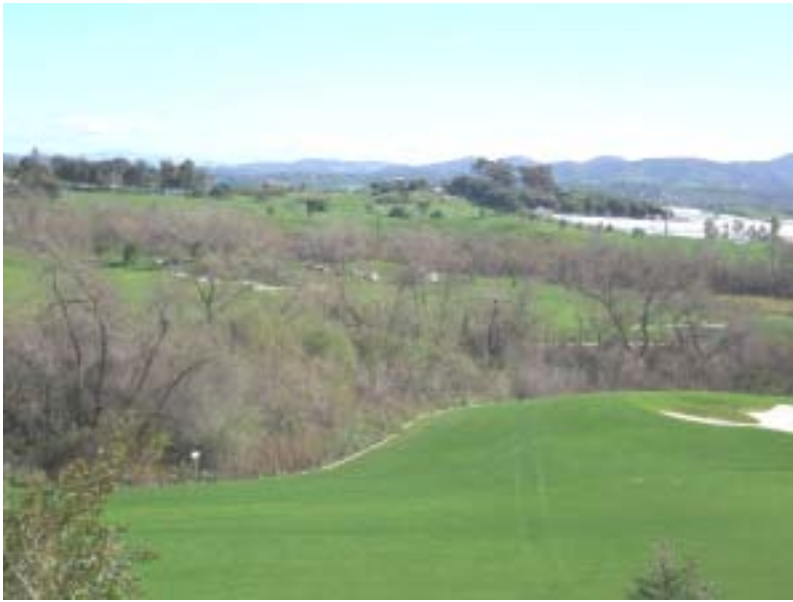
Golf course is near completion and mitigation areas seem to be prospering.
